**3000-HP ROLLER GEAR TRANSMISSION DEVELOPMENT PROGRAM
Volume VI - Reliability and Maintainability Report**

Sikorsky Aircraft
Division of United Technologies
Stratford, Conn. 06602

January 1977

Final Report

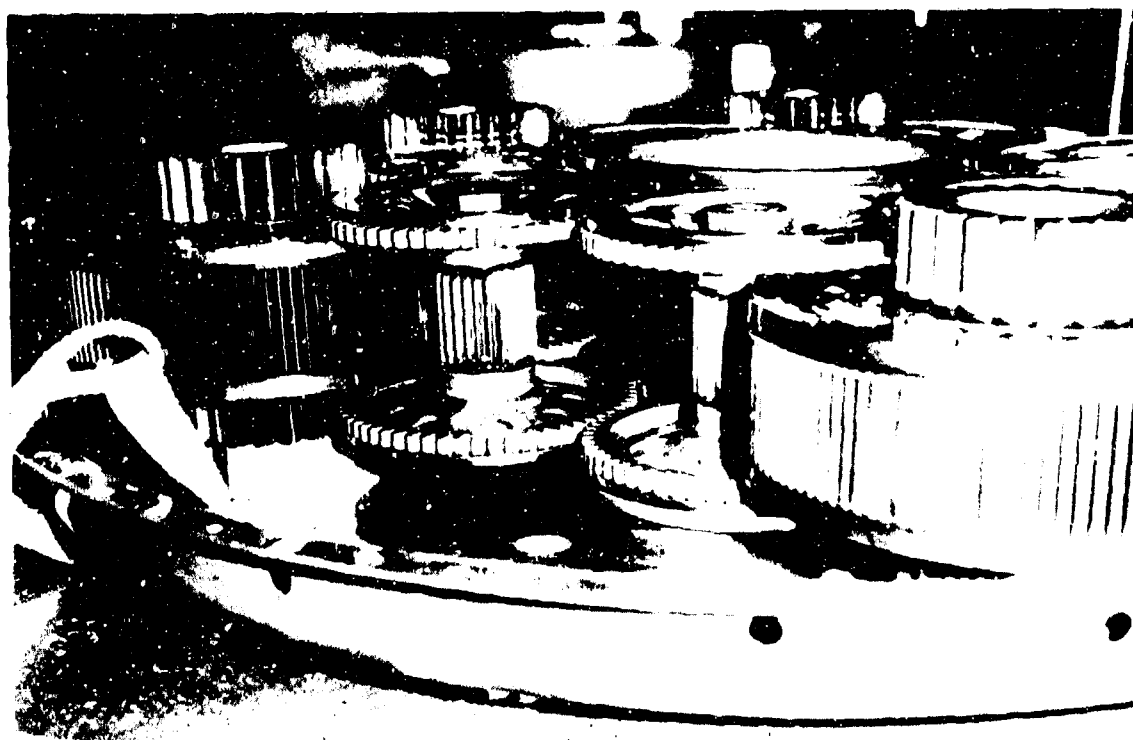
Figure B-4. First-Row Pinion Tooth Breakage.

With the incorporation of the butt weld design first-row pinion and modified second-row pinions, initial testing was continued. After approximately 21 hours of regenerative bench testing of the roller gear transmissions, the teeth of the first-row pinion, 27-tooth gear fractured (Figure B-4). Examination of the fractured gears revealed that the weld heat-affected zone extended into the carburized zone at the root of the gear teeth. This caused a transition interface which acted as a stress concentration between the compressive stress zone of the carburized teeth and the residual tensile stress zone of the weld. To prevent reoccurrence of this, the groove distance between the roller and gear was increased, thereby ensuring that the heat-affected area would not encroach into the carburized layers at the gear root.

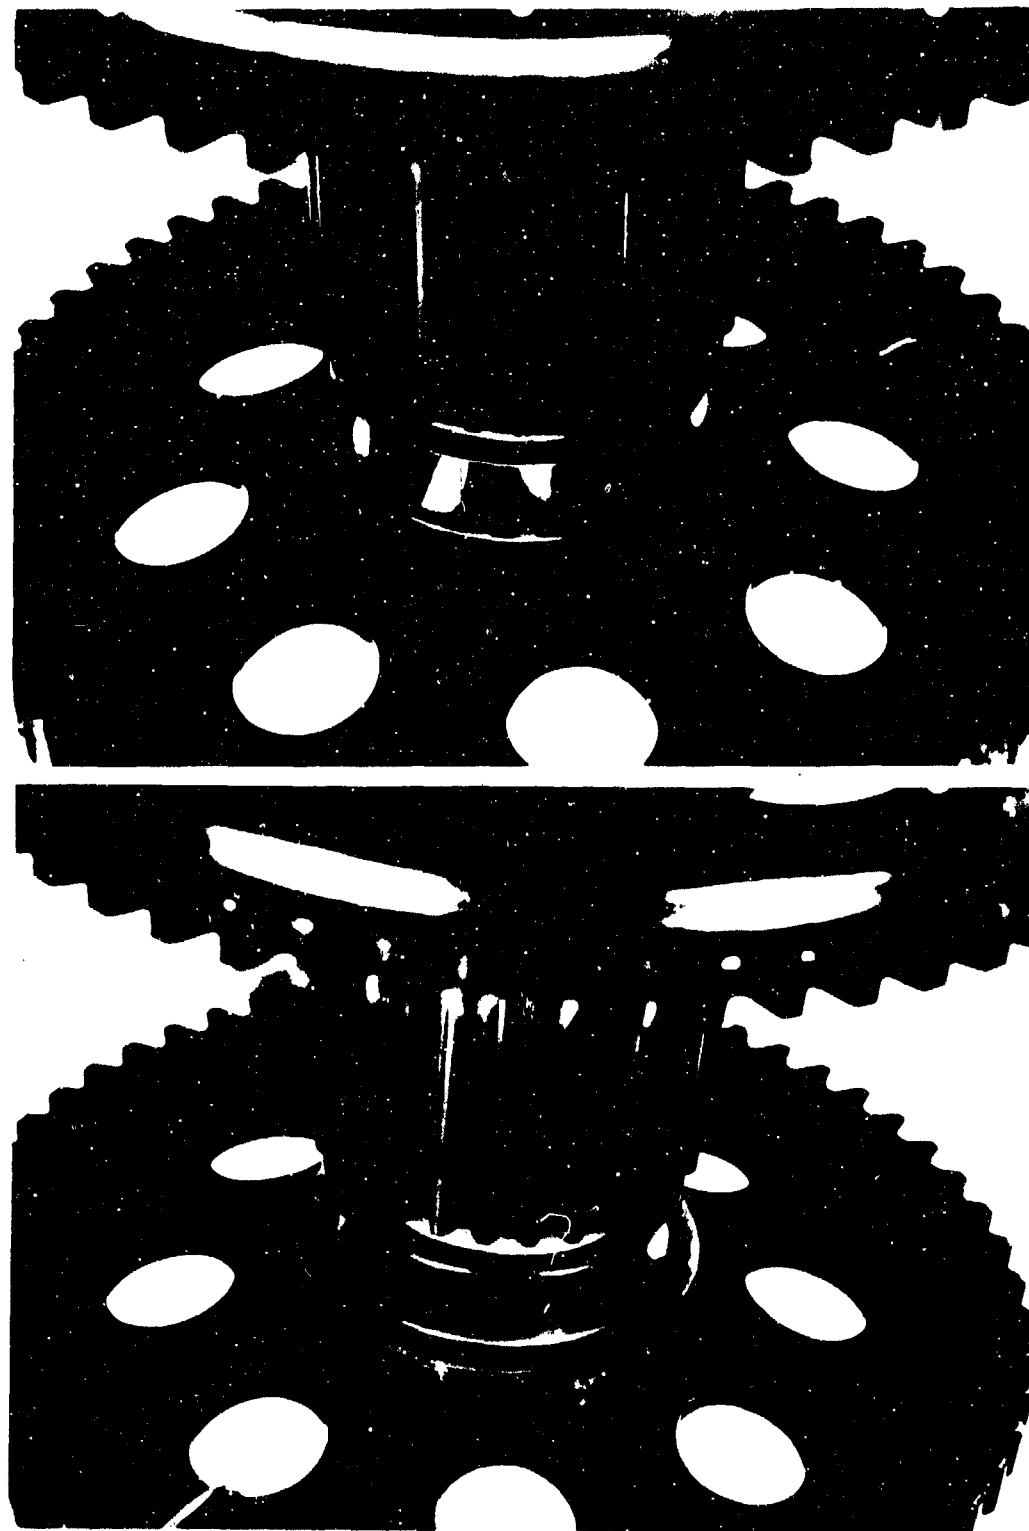
Figure C-8. Roller Healing, First-Row Pinion.

This type of self-healing phenomenon was noted by Franklin Institute Research Laboratories in Derivation of a Fatigue Life, Model for Gears, (11) wherein it was observed that shallow spalling of rolling contacting elements did not propagate deeper. Nonpropagation of surface spalling has also been noted by Onions & Archard, (12) who, in investigating the relationship between pitting of discs, suggested that the propagation of pre-pitting cracks that form pits can be inhibited by wear or plastic flow in the surface layers. It was concluded that, "a form of compliancy may be responsible for the fact that the cracks at the bottom of the shallow spall did not propagate under the Hertzian stresses or from lubricant-induced hydraulic pressure propagation." It is, therefore, concluded that the surface damage of the top roller surface of the first-row pinion, S/N 39, would not be detrimental.
